Montana Department of  
**ENVIRONMENTAL QUALITY**

**Subject: May 5, 2006, Compliance Evaluation Inspection - Asarco East Helena Plant**

**FIELD INVESTIGATION REPORT**

**SITE:** Asarco - East Helena Plant

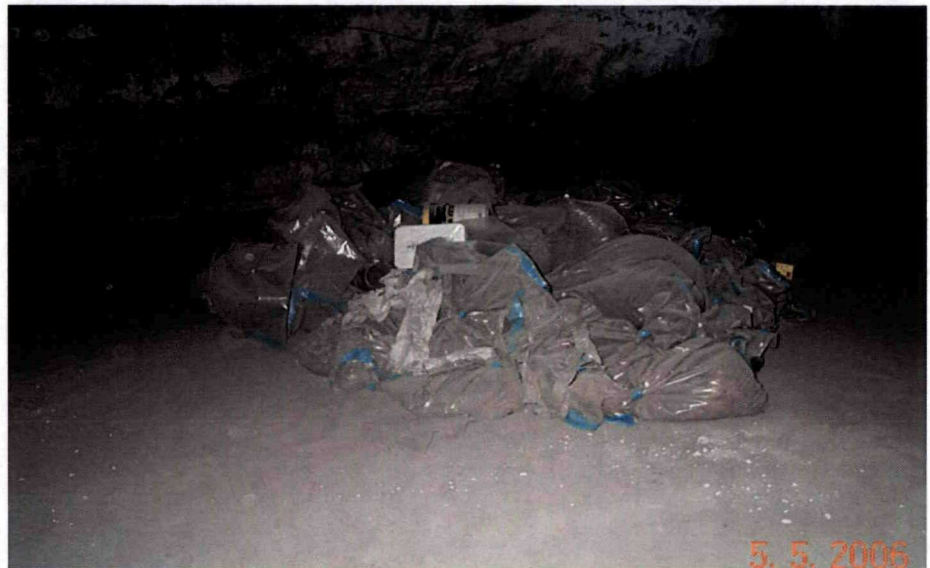
PHOTO #: ASARCO\_06125-038

Close-up of the plastic bags containing lead residue vacuumed up at the Sinter Plant using the red Vac truck.

The waste is stored in the southeast corner of the I-Bin in the CSHB.

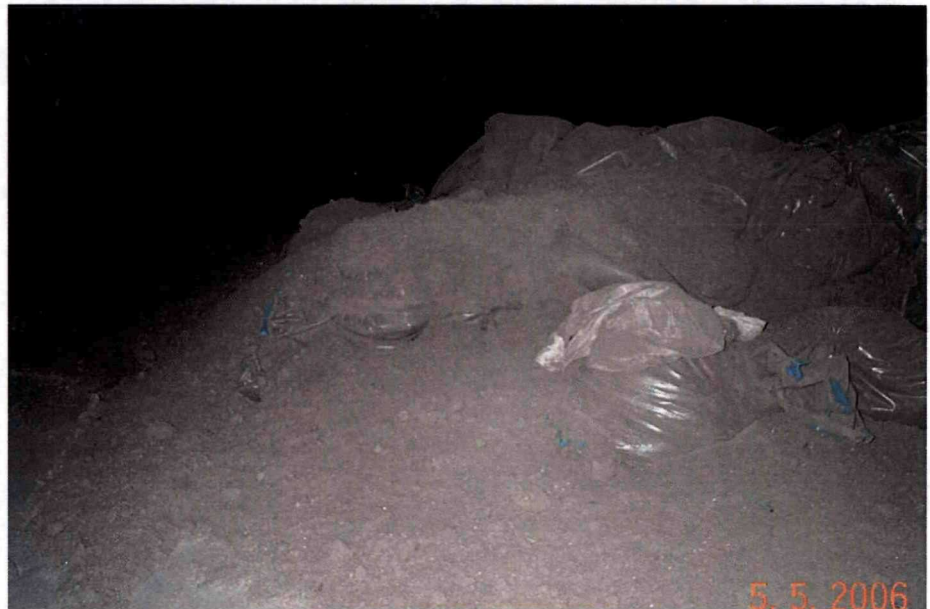
PHOTO #: ASARCO\_06125-039

Another view of the bags and loose residue collected via the Vac truck at the Sinter Plant and stored in the I-Bin of the CSHB.

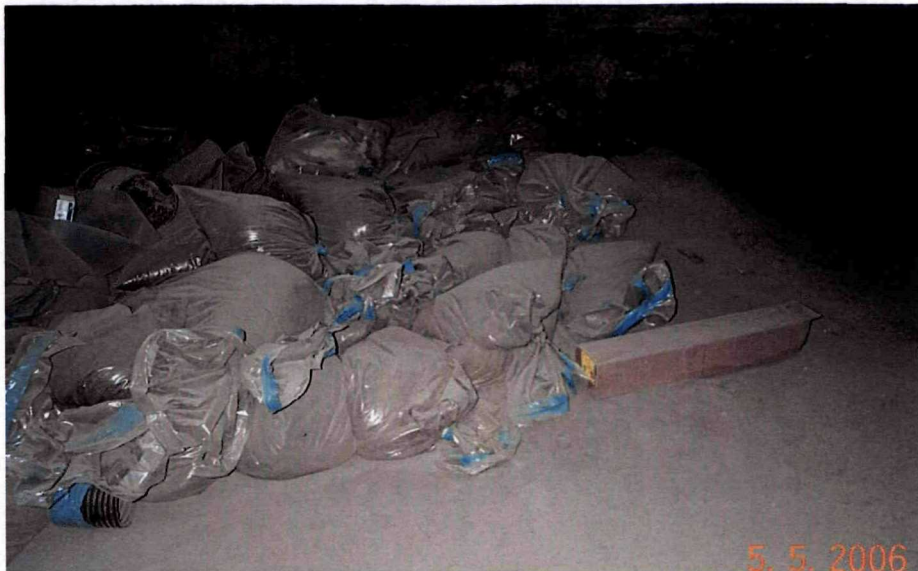
PHOTO #: ASARCO\_06125-040

One more photo of the bags and loose material from the Sinter Plant.

Approx. 35 yards of the waste was in accumulation at the time of the inspection.

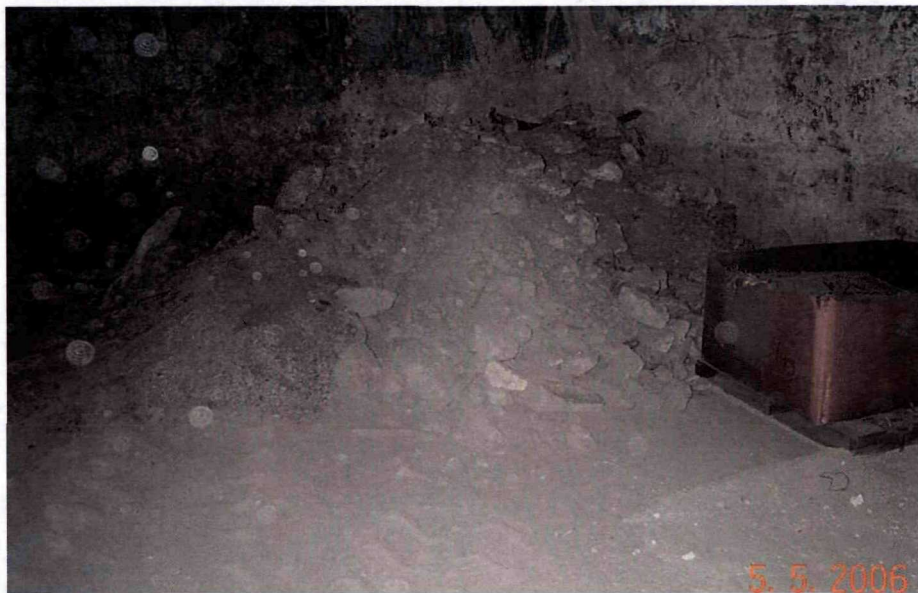
PHOTO #: ASARCO\_06125-041

In the northeast corner of the I-Bin in the CSHB, another pile of lead residue waste was observed during the inspection.

It should be mentioned here that all the waste material in the CSHB is destined for disposal either in the CAMU or at a TSDF.

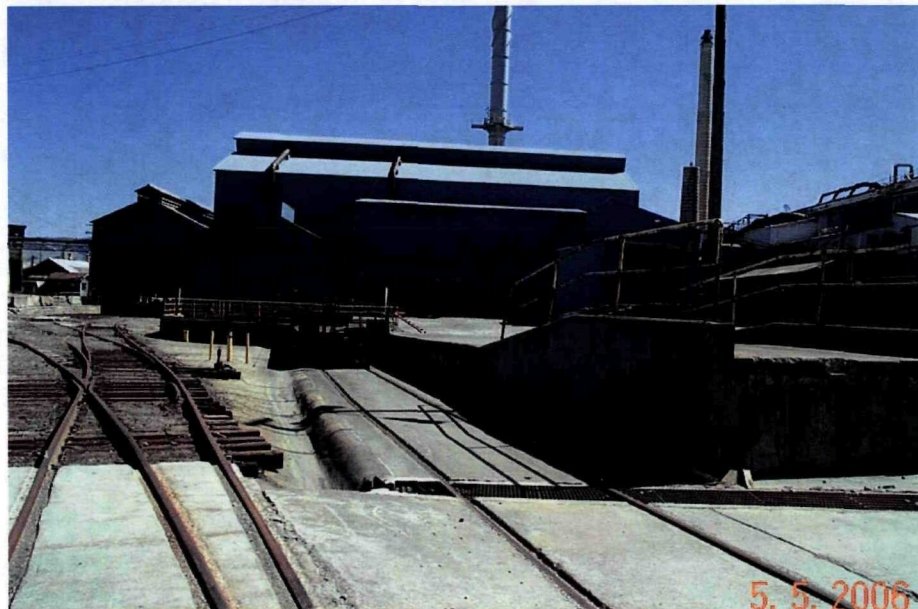
PHOTO #: ASARCO\_06125-042

According to Asarco personnel, all this will be demolished and leveled by the end of 2006 if all goes well.
